CHICKAMAUGA HYDRO PLANT UNIT REALIGNMENT

AS A RESULT OF CONCRETE GROWTH

J. C. Jones and M. A. Thompson
Tennessee Valley Authority
Hydro Equipment Group
Chattanooga, Tennessee

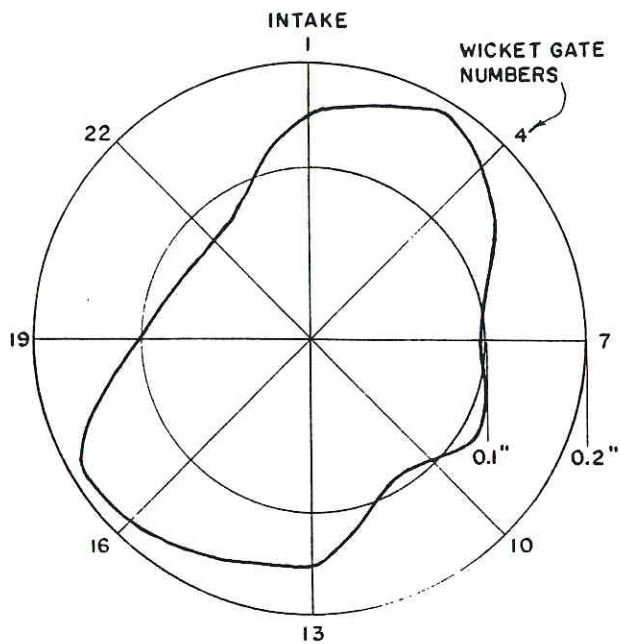
FIGURE 4 - PLOT OF THROAT RING

Figure 4 is a plot of the distance from the plumb wire to the throat ring wall. Figure 6 is a plot of the distance from the plumb wire to the center of the wicket gate bushing holes in the distributor ring. It is interesting to note that both of these plots are eggshaped and the axis of the major diameters coincide with the location of the nose vane as shown in Figure 3. Since the nose vane is located where the semi-spiral case has its minimum cross-sectional area, this would be where the embedded parts have their greatest structural support. The support of the embedded parts gradually decreases as the cross-sectional area of the semi-spiral case increases and approaches the intake as shown in Figures 2 and 3. We believe this explains the shape of the throat ring shown in Figure 4 and the direction of movement for the embedded parts.

In the past, as a temporary fix, areas on the throat ring were air-arc'd and ground smooth to maintain some blade clearance. This was corrected by building up the shallow areas with 308 stainless steel. Deep areas were built up with mild steel and then capped with 308 stainless steel. The throat ring was then ground to the proper diameter and contour.

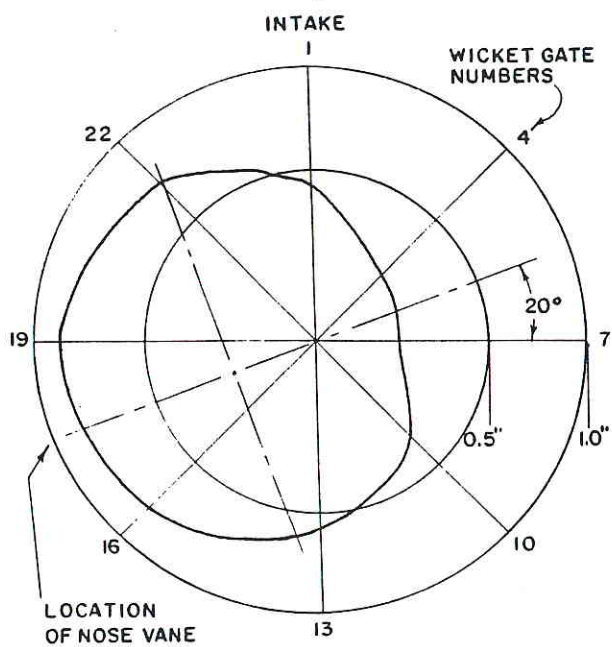
FIGURE 5 - PLOT OF OUTER HEAD COVER

Figure 5 is a plot of the distance from the plumb wire to the inner head cover-to-outer head cover fit on the outer head cover. The plot shows that the head cover is misaligned with the center of the throat ring by approximately 0.500 inch 20 degrees counterclockwise with the axis of the powerhouse. We believe that most, if not all, of this misalignment resulted from the movement of the lower part of the stay ring (including the throat ring and distributor ring) due to the shape of the throat ring shown in Figure 4. This means that the center of the throat ring has moved rather than the center of the outer head cover.

The wicket gates at Chickamauga are designed to operate with 0.040 inch end clearance. Calculations reveal that if the head cover is moved 0.250 inch out of line with the distributor ring, the end clearance will be exhausted and the gates will rub the head cover and distributor ring. Since a misalignment of 0.500 inch was found in unit 4, this explains why the wicket gates could not be completely close.

The outer head cover was removed from the stands and lowered back into place. Four aluminum plates were fabricated and installed in the wicket gate thrust bushing holes of gate numbers 3, 8, 14 and 20. A plumb wire was suspended through the center of each plate with a small plumb-bob attached and located in the corresponding bushing holes in the distributor ring. Measurements were taken and a move was plotted for the outer head cover. A small amount of metal had to be removed from the inside of the stay ring and the outer head cover flange bolt holes had to be elongated in order to move the outer head cover. The outer head cover was shifted to attain a compromise of all twenty-four wicket gate bushing holes and the center of the throat ring.
